Case Study 1

Scenario: A 1991 Buick Century sedan (Buick) was westbound and stopped at a stop sign at an intersection with a four lane divided highway. The female driver of the Buick intended to make a left turn on US-1. She pulled across the northbound lanes and stopped partially in the median to wait for traffic to clear in the southbound lanes so that she could complete her turn. Concurrently, a 1997 Kawasaki Vulcan 750 motorcycle (Kawasaki), operated by a male, was traveling in the left northbound lane of the highway. An impact occurred between the front of the Kawasaki and the left rear of the Buick. The Buick rotated counter clockwise heading east at final rest. The police report diagram (Figure 5-8) showed the final rest position to the south of its position at impact, which clearly violates the laws of conservation of linear momentum; however, the angle of final rest was confirmed by all parties to be accurate. The speed limit for the northbound traffic on US-1 was 60 miles per hour.

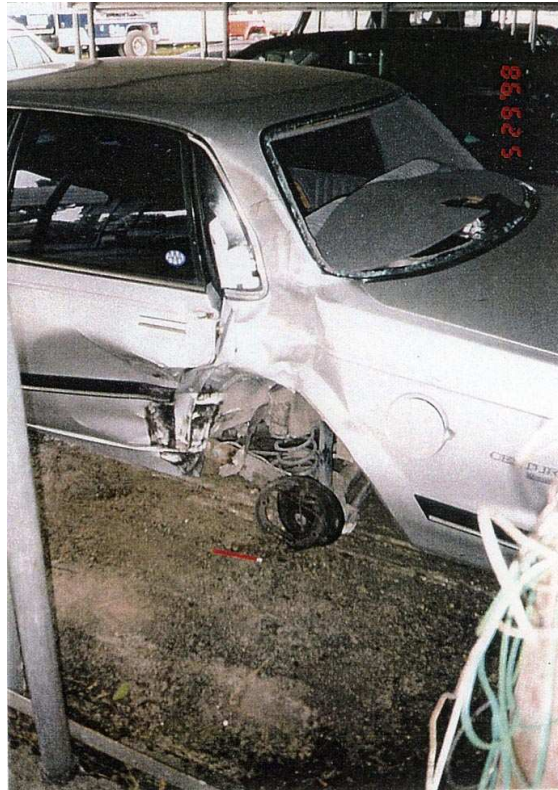
Figure 5-9

The damage to the Buick shows a distinct tire print on the rear edge of the left rear door, forward of the left rear wheel well. Additional damage is noted to the left 'C' pillar area. The left rear wheel is missing, with damage to the front portion of the wheel well. The unibody is bowed and concaved at the point of impact, Figures 5-9 and 5-10.

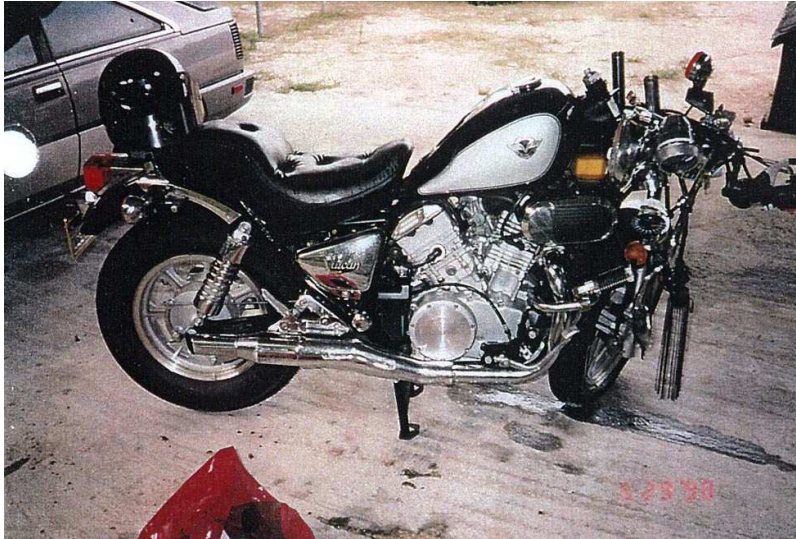
Figure 5-11

The photographs of the Kawasaki illustrate an impact from the front (Figures 5-11 and 5-12). The front fork tubes are bent rearward approximately 20° on the left and approximately 15° on the right. The handlebars were broken off the top of the fork tubes. The gas tank was dented on the top rear and demonstrated adjacent side damage that appeared to have been caused by compression from the sides due to the thighs of the driver. The front alloy wheel, which appears to have seven spokes, shows some deformation of the rim, consistent with an impact adjacent to one of the spokes. The tire and rim are pushed into the radiator/engine area of the motorcycle. The front tire appears to still be inflated.

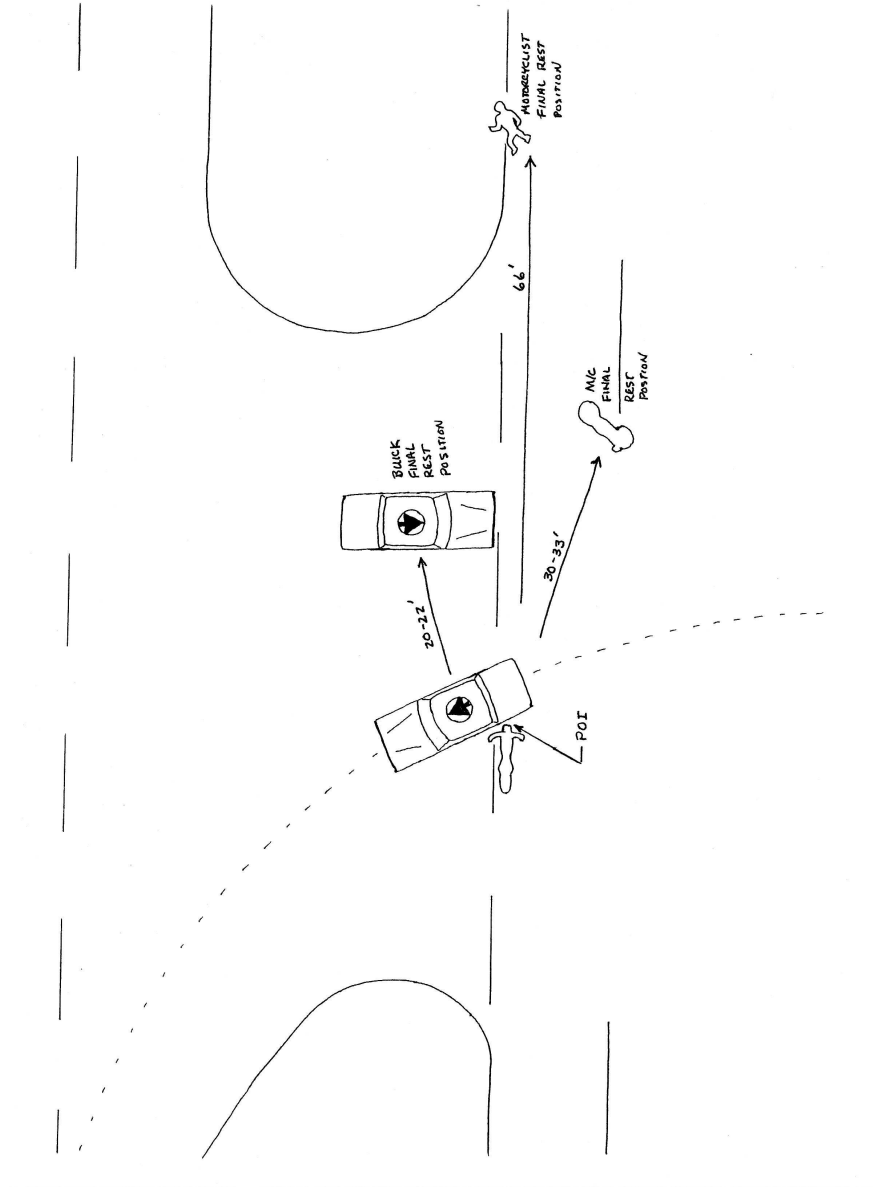
Figure 5-13

The roadway was inspected and documented. A scale diagram of the scene was drawn, as shown in Figure 5-13. The approximate point of impact was based on the geometry of the intersection and statements of the Buick's driver. The post impact position of the Buick was based on testimony of the two drivers and a witness that arrived on the scene before the Buick was moved. The final rest of the Kawasaki based on a fluid mark on the roadway. The final rest of the Kawasaki driver was based on his testimony.

The vehicle is at an approximate 20 degree angle with the roadway, therefore, the perpendicular distance to the line of force is calculated as follows (refer to Figure 5-13):

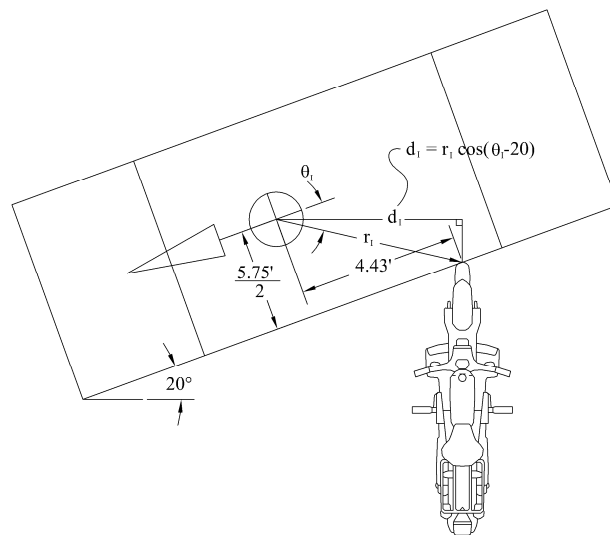
Figure 5-14

$$\theta_i = \tan^{-1}\left(\frac{W_v/2}{d}\right) = \tan^{-1}\left(\frac{5.75/2}{4.43}\right) = 33^\circ$$

$$r_i = \sqrt{\left(\frac{W_v}{2}\right)^2 + d^2} = \sqrt{\left(\frac{5.75}{2}\right)^2 + (4.43)^2} = 5.28 \text{ ft}$$

$$d_i = r_i \cos(\theta_i - 20) = 5.28 \cos(33 - 20) = 5.14 \text{ ft}$$
