Vehicle Linear and Rotational Acceleration, Velocity and Displacement during Staged Rollover Collisions

Orion P. Keifer, Wesley C. Richardson, Peter D. Layson,
Bradley C. Reckamp, and Thomas C. Heilmann
Applications Engineering Group, Inc.

ABSTRACT

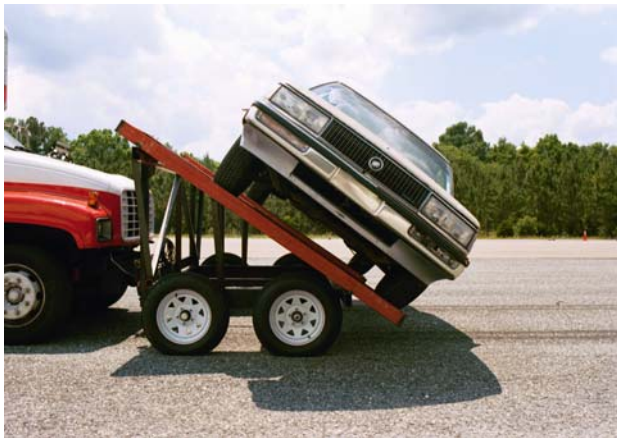
The sled was manufactured using a utility trailer frame set side-ways. Two fixed axles were attached to the frame. Two ramps, one for the front and one for the rear axles, were welded in

place at an angle of approximately 34° (Figure 1). The designed ramp angle was determined using a first order approximation, neglecting suspension compliance, such that all test vehicles would: first, be stable while the sled was stopped or accelerating and second, roll off the sled when the pusher truck was heavily braking. Rollover occurs when the line of action of the force through the center of gravity of the vehicle is forward of the front lip of the sled. That occurs when the sum of three angles exceed 90°. The three angles are the sled ramp angle, the angle formed by the ground and a line passing through the vehicle center of gravity, with the apex at the center of the outboard tire, which is calculated using the Static Stability Factor (SSF) and the friction angle due to braking, shown on Figure 2. In this first order approximation, the braking deceleration required to cause the vehicle to roll was calculated between 0.35 and 0.4 g's, depending on the test vehicle. The front bumper of the pusher truck was removed and brackets fabricated for this test were mounted on the frame members. The sled was then pinned to the frame brackets with two transverse pins, one for each side.

Figure 1. Photograph of the sled arrangement.

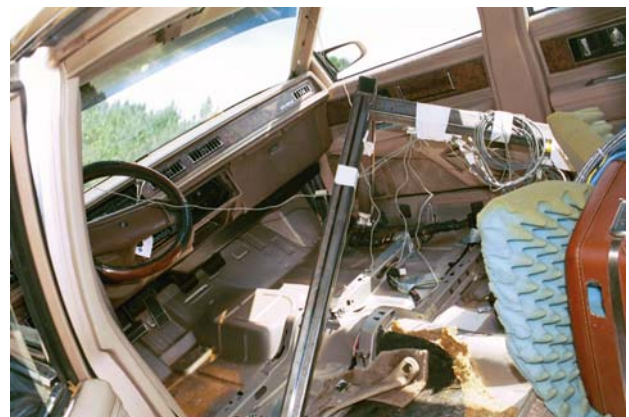
Figure 3 shows a photograph of the test equipment installed in one of the test vehicles.

Figure 3. Photograph of the nine-accelerometer array frame inside a test vehicle.

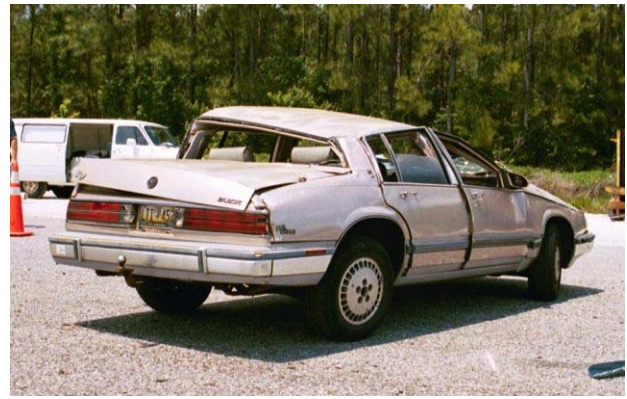
Figure 4. Buick

Figures 4 through 7 show the damage received by the four vehicles during the rollover.

The Buick angular velocity barely reached 6 radians per second. At the end of the second roll, the vehicle landed relatively hard on its wheels, and the rotation was abruptly stopped. The Buick experienced a very slight approximately 10° clockwise CW yaw in the last ½ roll.

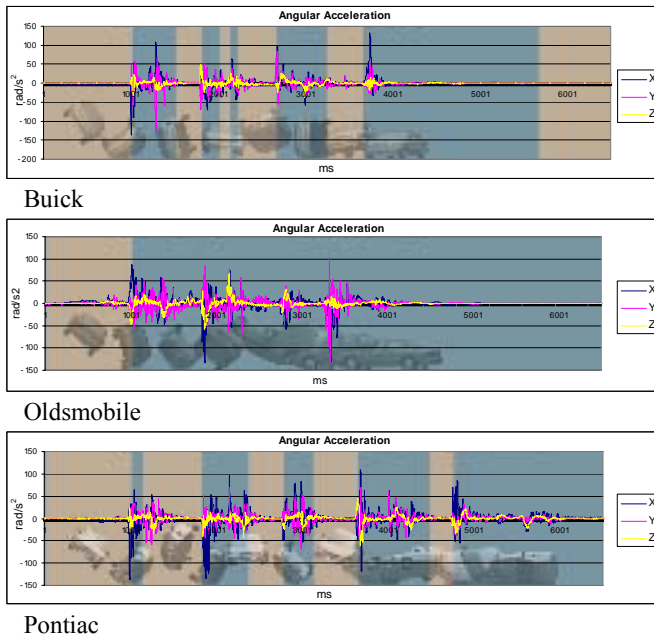
The rotational acceleration data for the Buick, Oldsmobile and Pontiac are presented in Figure 9. Note that the horizontal axes are matched for the

three vehicles for comparison. Darker background indicates ground contact of the vehicle, based on video analysis. Larger graphs are presented in Appendix C.

Figure 9. Triaxial angular acceleration for all three vehicles. Larger graphs are presented in Appendix C.

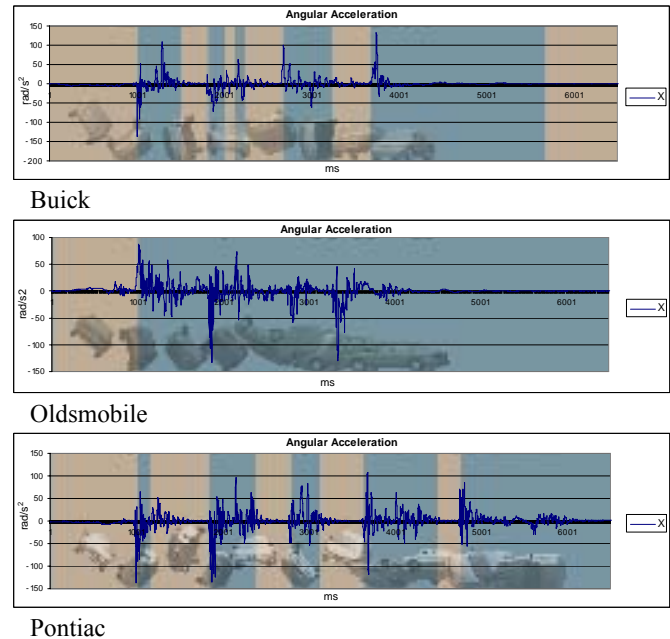
The X-axis rotational acceleration for the three vehicles is presented in Figure 10 and the X-axis rotational velocity for the three vehicles is presented in Figure 11. Note the darker background indicates that the vehicle is touching the ground and the light background, the vehicle is fully in the air, as determined by video analysis/photogrammetry. Clearly the ground contacts can be seen as linear and rotational acceleration spikes.

Figure 10. Rotational acceleration for X-axis for the three vehicles. Larger graphs are presented in Appendix C.

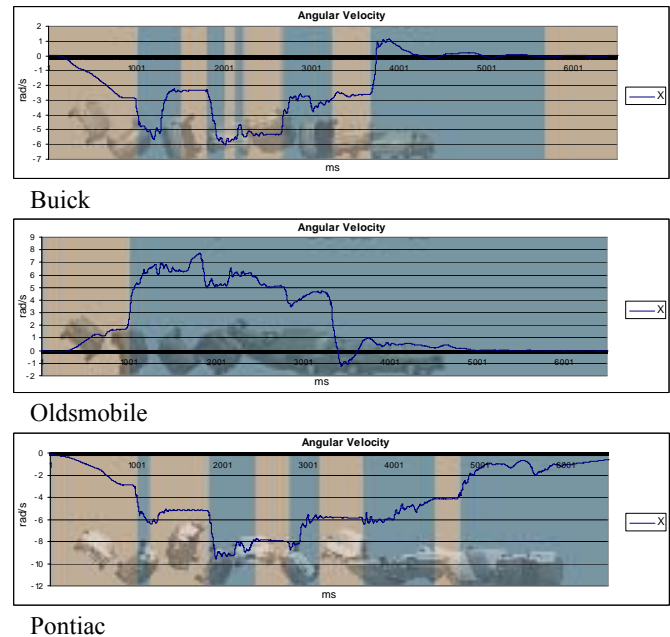
Figure 11. Angular velocity for all three vehicles. Larger graphs are presented in Appendix C.

The angular roll velocity achieved by the Buick and Oldsmobile was approximately one revolution per second. As mentioned earlier, the Pontiac's angular roll velocity was approximately $1\frac{1}{2}$ revolutions per second after the second ground impact, but decreased to approximately 1 revolution per second after the third ground impact.

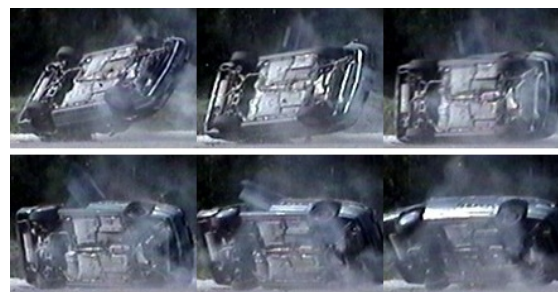
Figure 15. Oldsmobile test. Note the passenger side rear door opened and then shut (top rear in the video sequence above).

While reviewing the video, it was discovered that the passenger rear door on the Oldsmobile opened and then slammed shut during the roll sequence (Figure 15). At final rest, the door was latched shut.
